**Article 4-203.G.4
Geologic and Soils Hazard
Report**

**Major Impact Review Application
Battlement Mesa PUD Phase I
BMC B**

NATURAL AND GEOLOGIC HAZARDS ASSESSMENT REPORT

**URSA OPERATING COMPANY
BMC B PAD SITE – COUNTY ROAD 307
SW ¼, NW ¼, SECTION 18, T7S, R95W, 6TH P.M.
GARFIELD COUNTY, COLORADO**

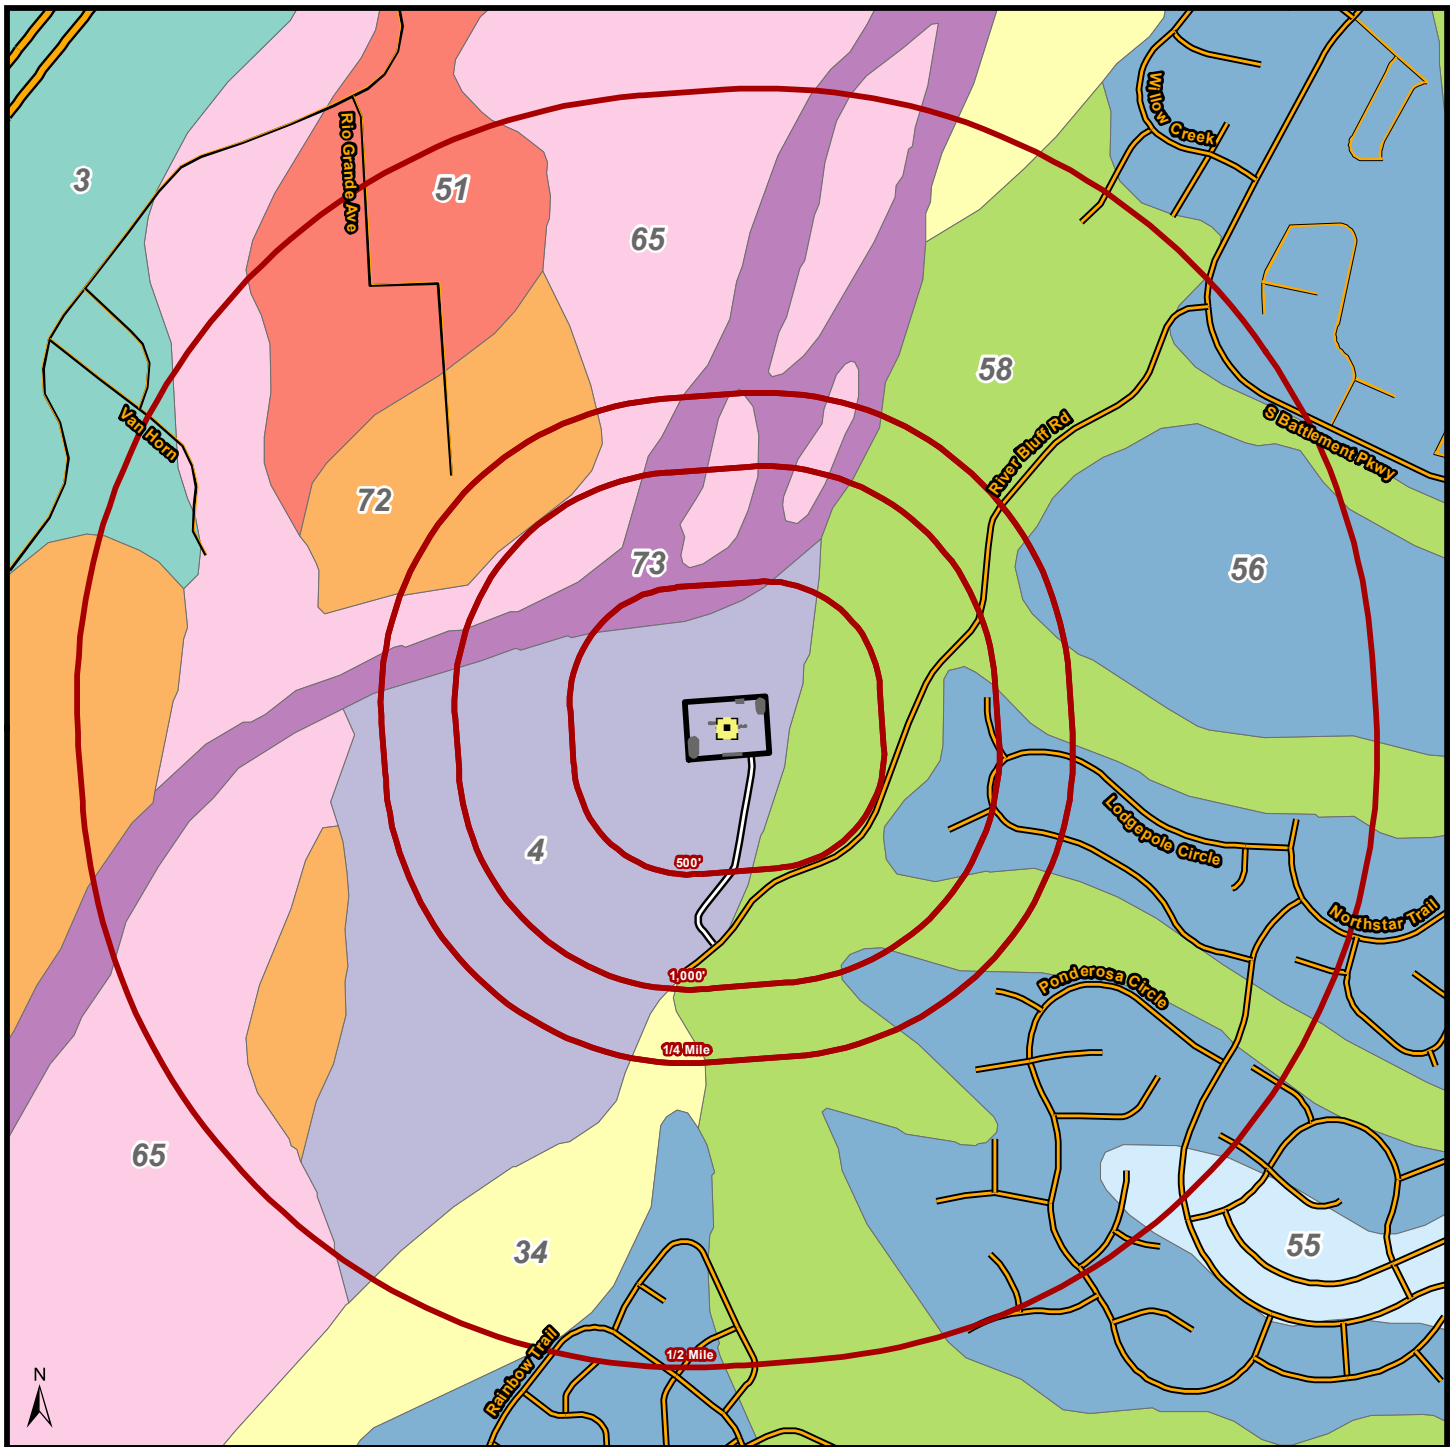
NRCS SOILS KEY:

| Map Symbol 4 – Arvada loam (6-20% slopes) | |
|---|---|
| Development is limited by the high shrink-swell potential, salinity, and steep slopes. This soil is in capability subclass VII _s , nonirrigated. | |

3.7 Corrosive or Expansive Soils and Rock
